MENAPS 2022

Enhance the Use of Shot Detection Acoustic Device in TCP Operations

MENAPS-01-22

AUTHORS: Mohammed Taiwani (RAY International), Nasser Nadhairi (RAY International), Ibrahim Breiki (RAY International), Hanaey Ibrahim (DYNA Energetics)

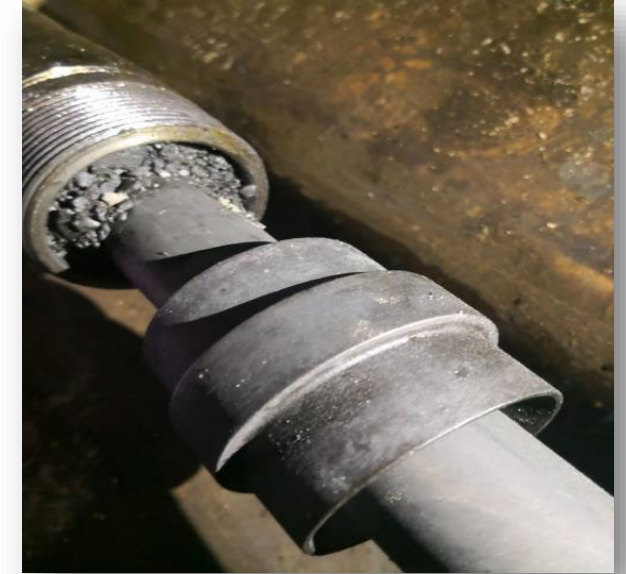
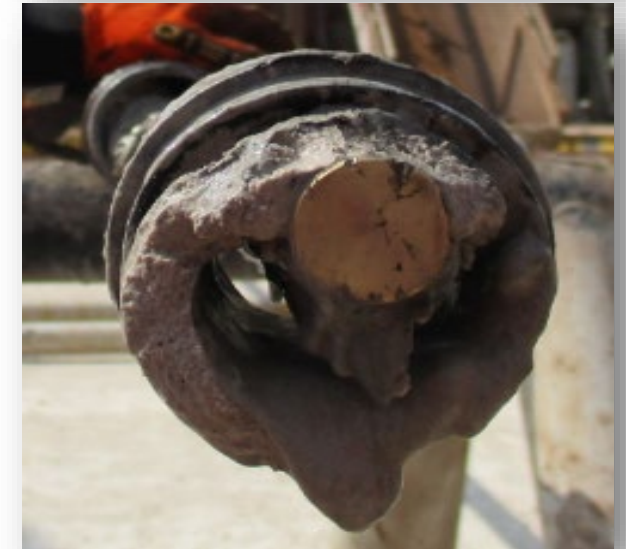
Drop Bar Firing heads will start failing when well conditions are not ideal; meaning:

- Wells are inclined over 45°.
- S-Shape wells that can disturb bar speeds.
- Tubular constant change of IDs.
- Debris settlement around the firing head sub.

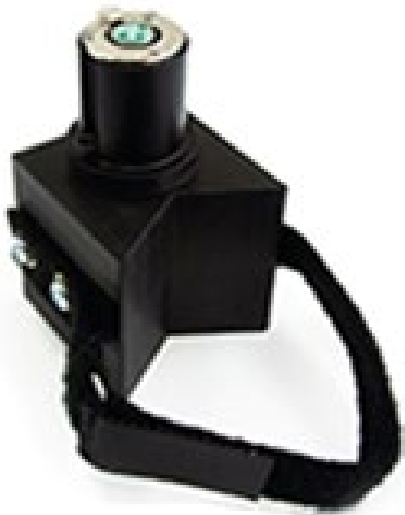
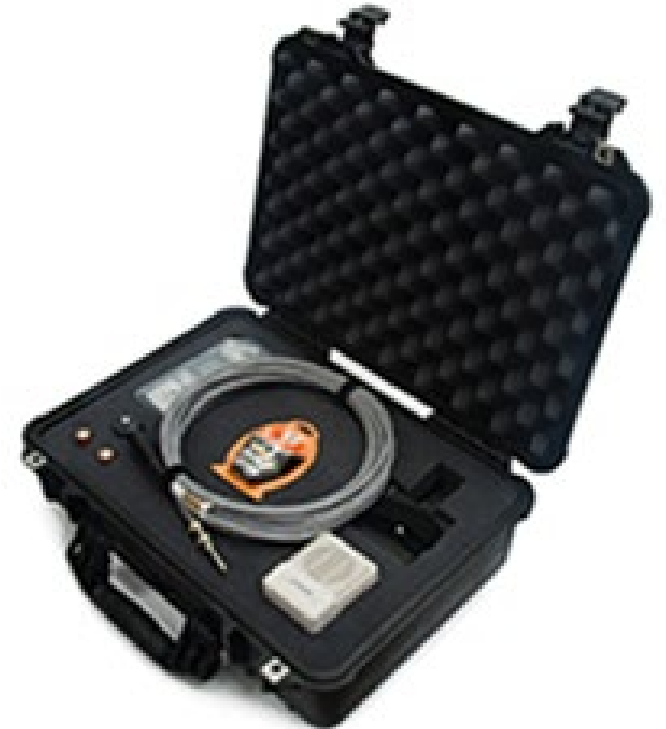
TCP Shot Detection System benefits and features:

- Crisp and clear audio signals make easy identification of gun detonation.
- Rapid and informed decisions can be made real-time.

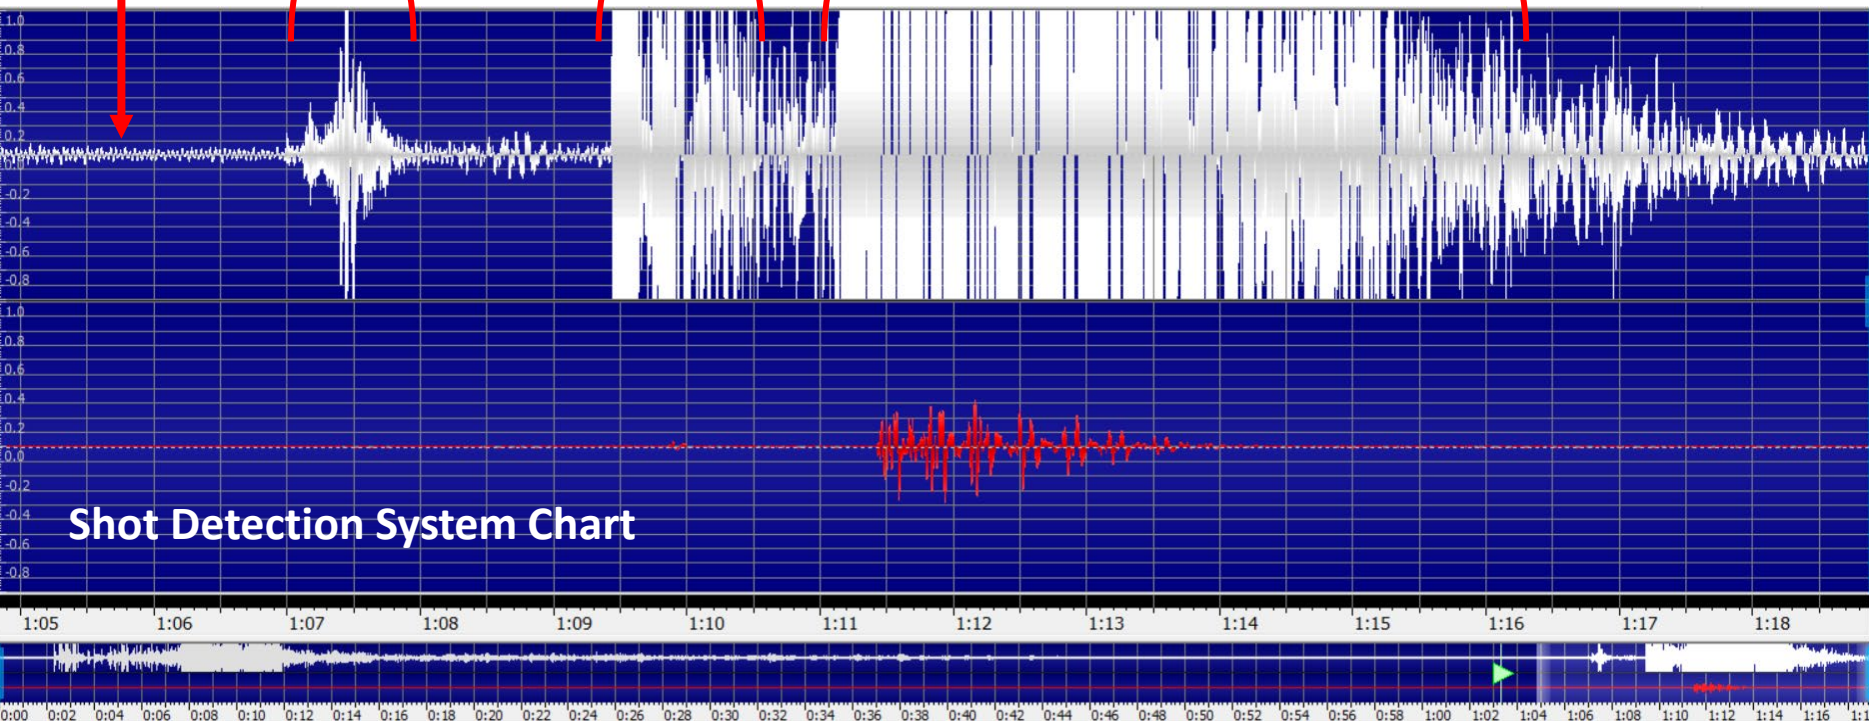
Shot Detection System Chart

- Bar Travelling inside fluid in Tubing
- Drop Bar Hit Non-ported Sub (Glass Disc)
- Bar Break BPV Pin & open valve (communication established between Rat Hole & TBG)
- Drop Bar Reached Firing Head & TCP Gun Firing Indication

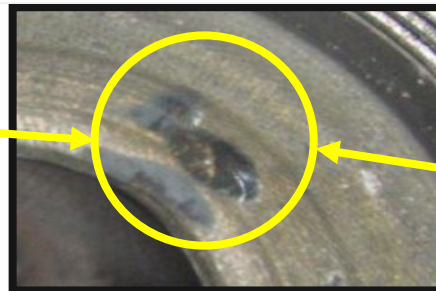
Deep Mark of Drop Bar at the 1.5" ID Crossover. X/O was at depth 3327m (which was above BPV)

Drop bar normally travels 30m in 3 seconds. However, due to drop bar impact in X/O it lost its complete speed & took 11.5 seconds instead. Acceleration and velocity was not enough to pass through solids/sand settling on top of the glass disc.

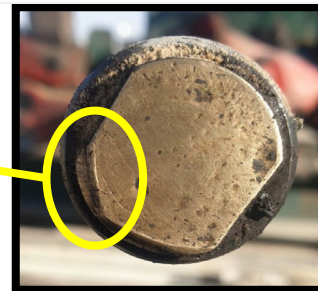
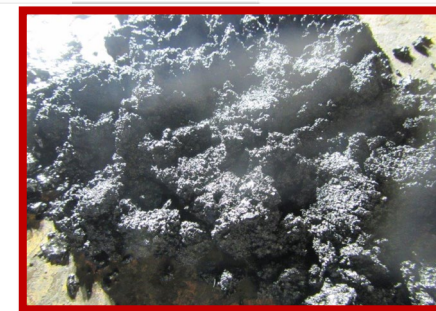
Solids/Sand found above FH after POOH

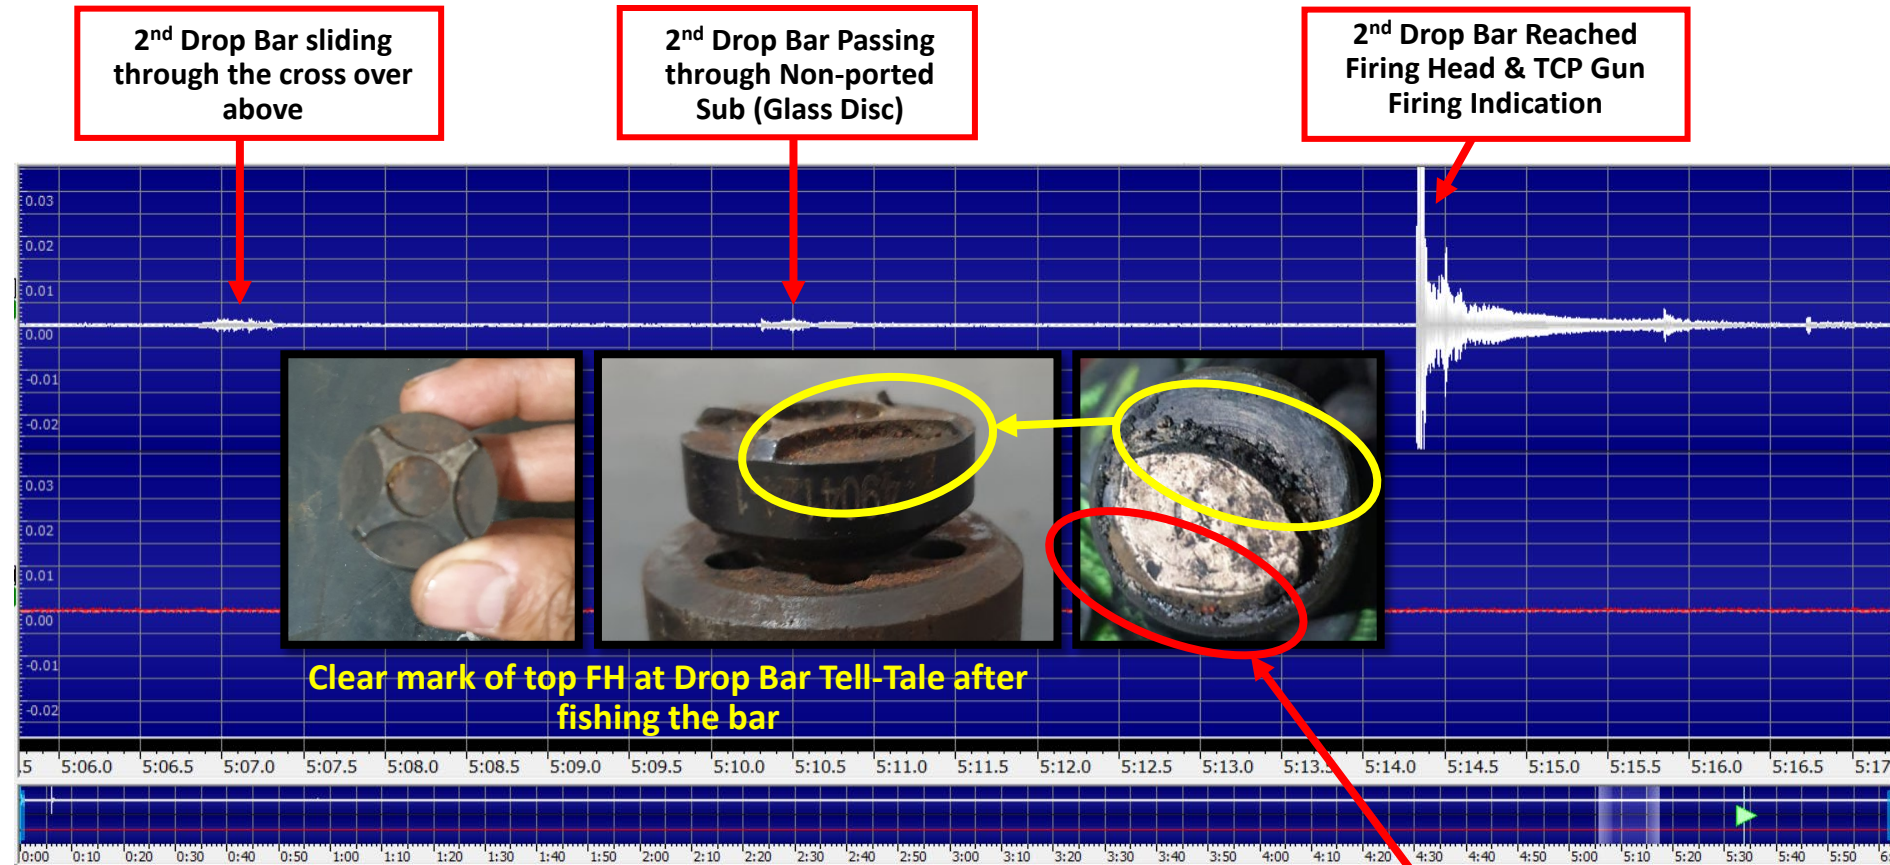
Drop bar failure investigation

Mark of 2nd drop bar touching the tip of 1.5" ID cross over while travelling down

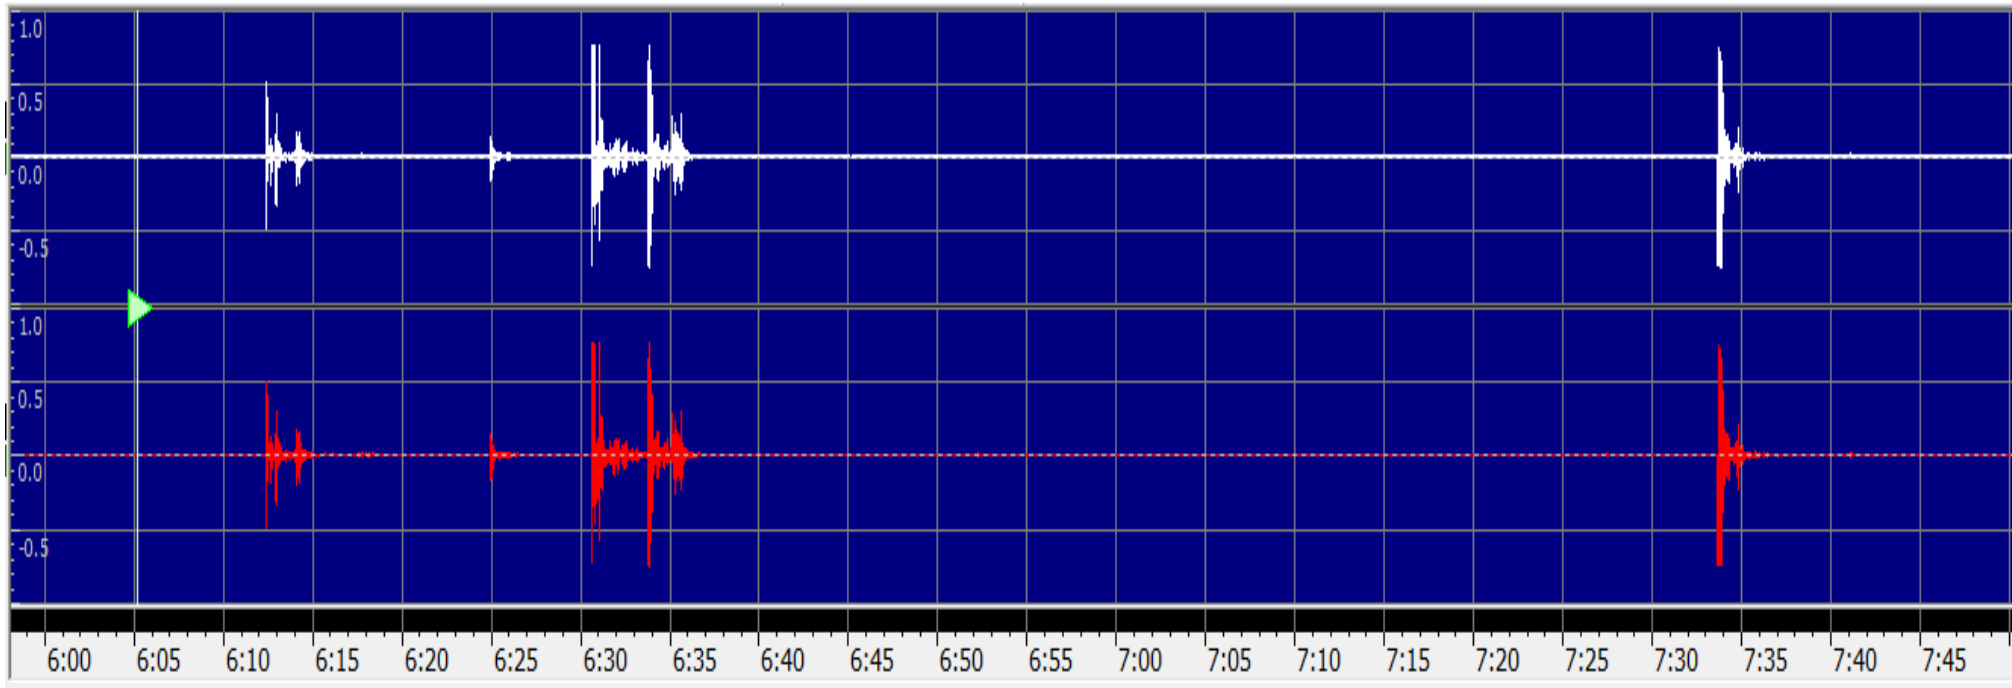
Detecting Multiple Firing Heads Detonation

- Using same activation pressure and delay time.
- All zones detonation indications was easily identified by Shot Detection System.
